## Service Success Story

## High-Performance Coupling Rebuild Gas Compressor

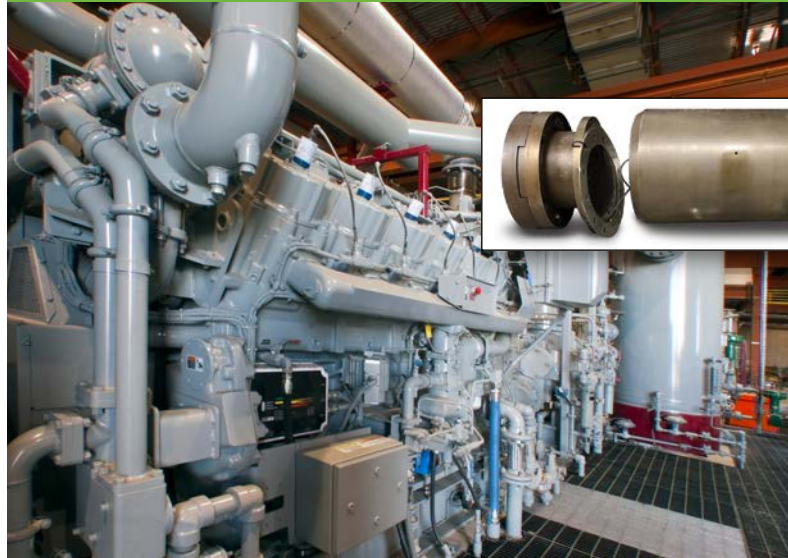
Before Rebuild

After Rebuild

A team of highly experienced technicians and engineers disassembled, inspected and shot blasted the coupling upon its arrival at the Rebuild Center. All major components were found to be in good condition after being measured on a Coordinate Measuring Machine (CMM) and subjected to non-destructive Magnetic Particle Inspection (MPI) testing. All fasteners and flexible elements were replaced. The coupling was phosphate-coated for corrosion resistance, re-assembled and balanced.

- Major components were shot blasted
- Critical dimension checks completed on all parts
- MPI inspection performed
- All flexible elements and hardware replaced
- Unit was phosphate-coated, re-assembled and balanced prior to shipping
- Returned to “like new” condition with full 1-Year warranty
