Service Success Story

Expedited High-Speed Coupling Rebuild

Gas Turbine

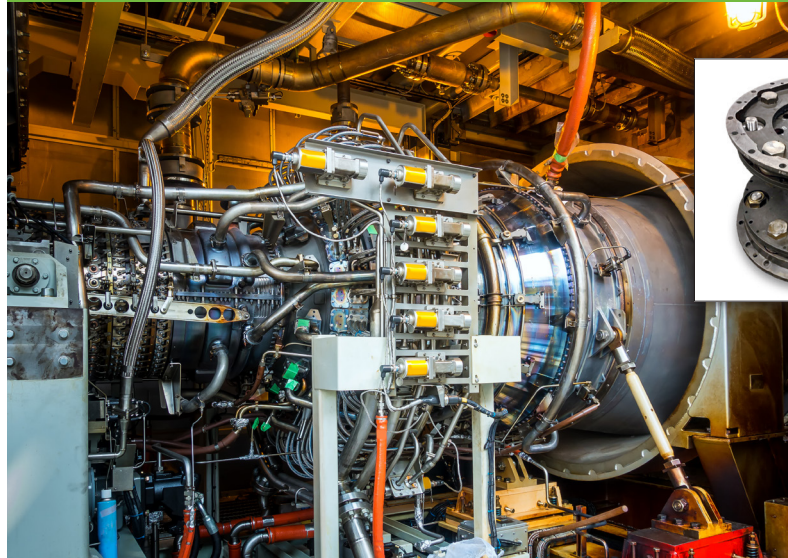
Before Rebuild

After Rebuild

- All components were measured on the Coordinate Measuring Machine (CMM).
- Non-destructive Magnetic Particle Inspection (MPI) testing was completed.
- Bearing stub shaft thread was stripped and needed to be replaced.
- Adaptor plates were cleaned.
- All wear components, including bearings, flexible element packs and fasteners, were replaced.
- Shear pins were removed and replaced.
- The coupling was phosphate-coated for corrosion resistance, re-assembled and balanced.
