Application Success Story

V-Belt Sheaves Wood Chippers

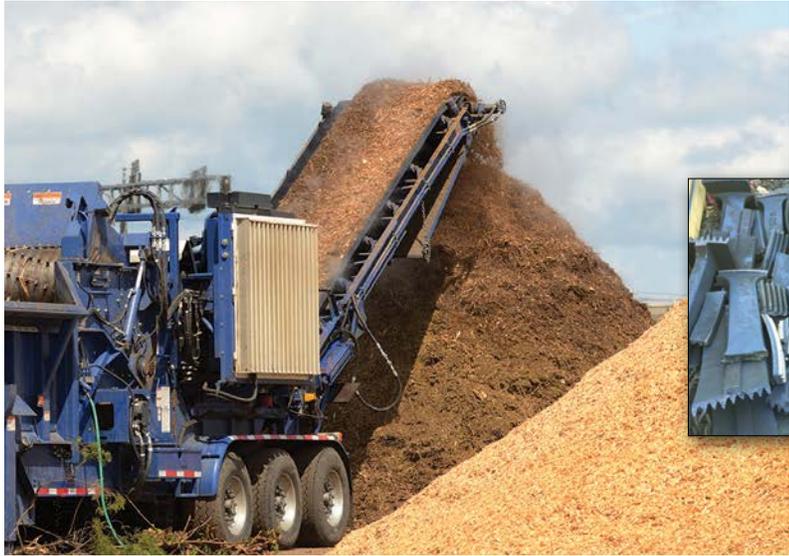
Severely damaged competitor sheave and belts

A major manufacturer of commercial wood chippers had experienced the complete failure of an imported belted drive installed as a replacement on a chipper from a product line that it recently acquired. After a period of use, the drive sheave broke apart, causing significant damage to the belt drive and other machine components.

After careful examination of the drive design, TBW engineers uncovered multiple problems with the competitor's drive that would have contributed to the drive's eventual failure. The competitor drive utilized cast iron, 8-groove sheaves and 5VP belts. Unfortunately, this drive configuration was not designed correctly and used the wrong belt type, number of grooves, and material type for the speed of the drive.

Based on the chipper horsepower and speed requirements, TBW engineers recommended the use of paired 12-groove ductile iron sheaves with expanded capacity 8VP belts. A cross section of the new recommended sheave clearly showed how much more robust the TBW casting was compared to the failed competitor sheave.
