## Service Success Story

## High-Performance Disc Coupling Rebuild Gas Terminal Compressor

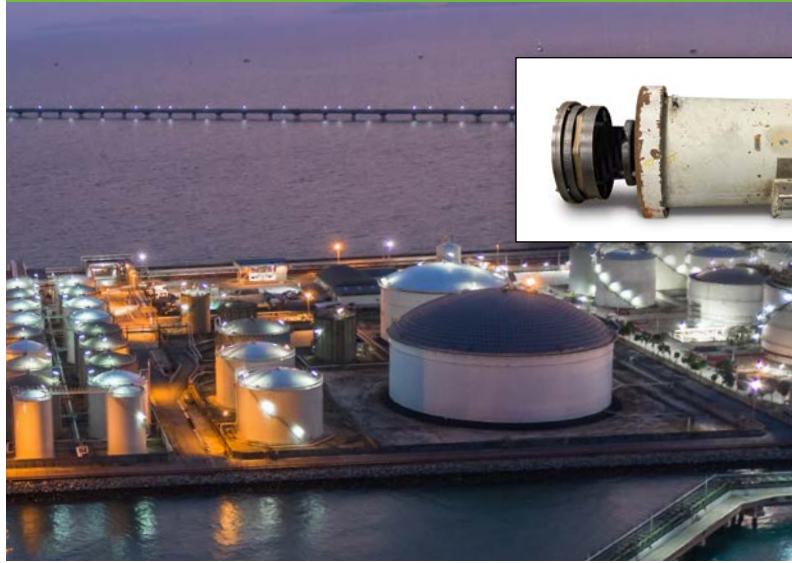
Before Rebuild

A Bibby high performance 305S Torquemeter disc coupling, installed between a gas turbine and a high speed compressor, had been in service for more than 23 years so the operators decided to swap in a spare coupling and send the original coupling to Bibby for a “health check” and any necessary refurbishment.

After the refurbishment quote was approved, all flexible elements and hardware was replaced. The coupling was then re-phosphated, re-assembled and balanced prior to shipping. The rebuilt coupling was returned to “like new” condition and delivered to the customer with a full 1-year warranty.
