Service Success Story

High-Performance Disc Coupling Rebuild Gas Terminal Compressor

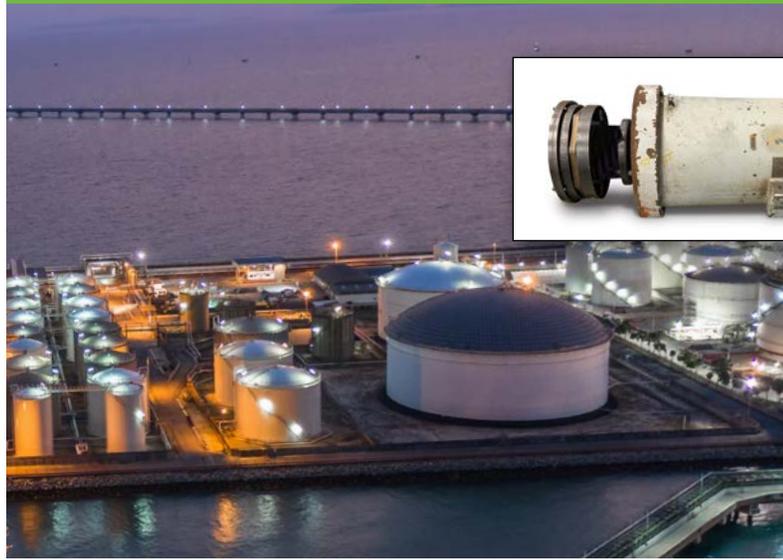
After
Rebuild

Before Rebuild

A Bibby high performance 305S Torquemeter disc coupling, installed between a gas turbine and a high speed compressor, had been in service for more than 23 years so the operators decided to swap in a spare coupling and send the original coupling to Bibby for a “health check” and any necessary refurbishment.

- All components were cleaned, de-greased and checked
- Major components were shot blasted
- Critical dimension checks completed on all parts
- MPI inspection performed
- Written inspection report prepared
- All flexible elements and hardware replaced
- Unit was phosphated, re-assembled and balanced prior to shipping
- Returned to “like new” condition with full 1-Year warranty

After the refurbishment quote was approved, all flexible elements and hardware was replaced. The coupling was then re-phosphated, re-assembled and balanced prior to shipping. The rebuilt coupling was returned to “like new” condition and delivered to the customer with a full 1-year warranty.
