# SVENDBORG BRAKES RESURFACING IMPROVES YAW BRAKE PERFORMANCE

# SVENDBORG BRAKES RESURFACING IMPROVES YAW BRAKE PERFORMANCE ON ORE CATAPULT'S TEST TURBINE IN SCOTLAND

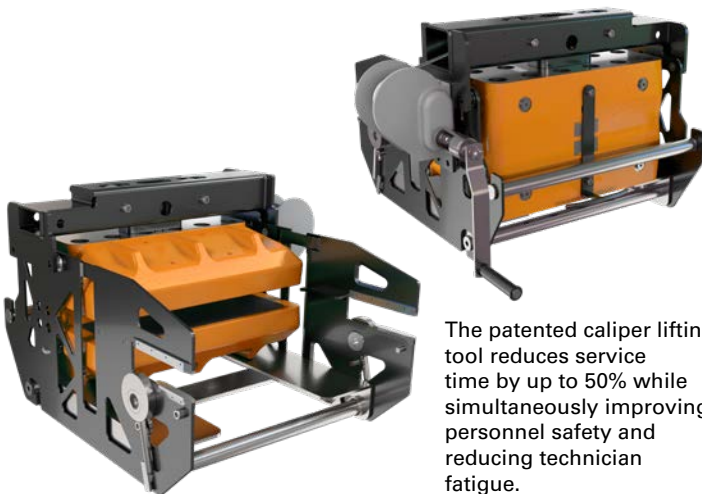
The patented caliper lifting tool reduces service time by up to 50% while simultaneously improving personnel safety and reducing technician fatigue.

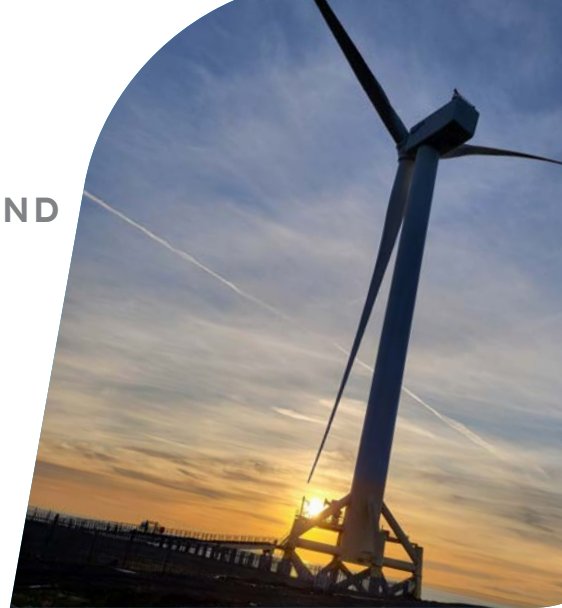
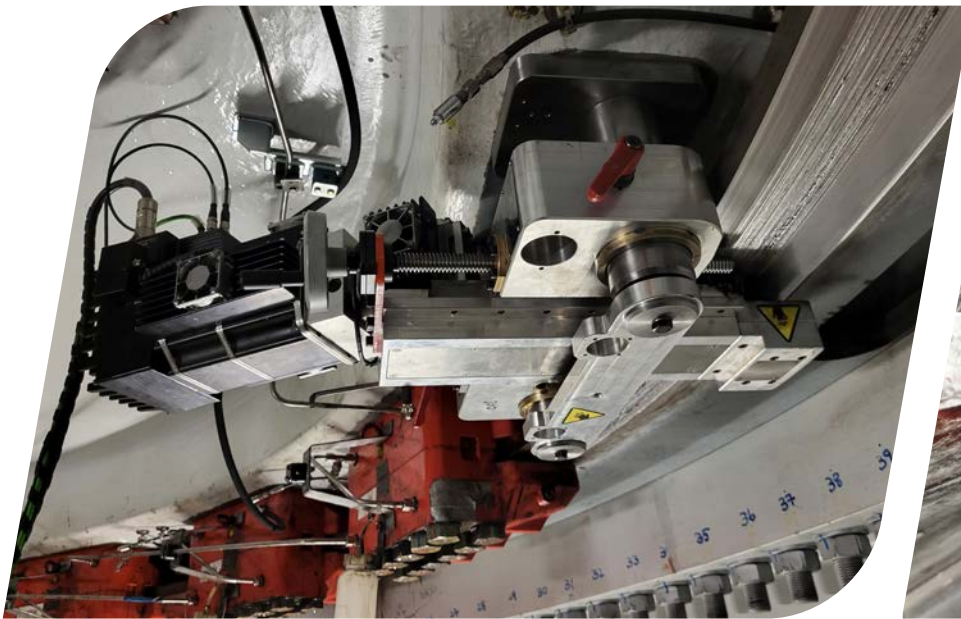
Svendborg Brakes DRT gen2 tool was mounted to mill the damaged disc surface.

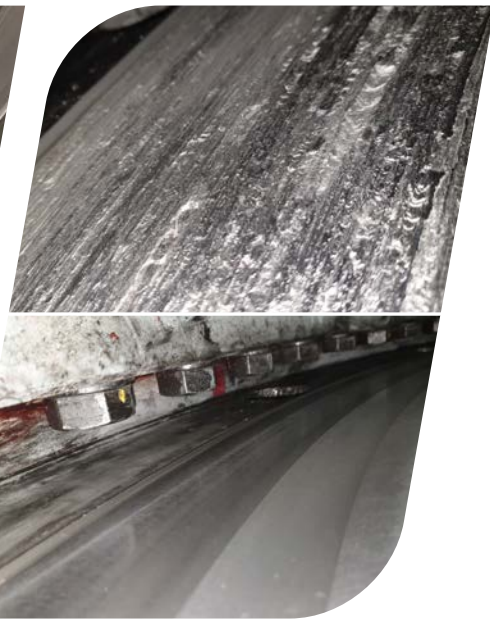
Engineers from the Wood Group identified a damaged yaw brake disc on the Offshore Renewable Energy (ORE) Catapult's Samsung 7MW wind turbine based in Levenmouth, on the east coast of Scotland. The damaged disc was causing increased and uneven wear on the brakes' caliper pads, forcing turbine operations and maintenance specialists to purchase new pads and replace them more frequently.

Top: Disc surface before milling.  
Bottom: Disc surface after DRT gen2 milling.

Experts from Svendborg Brakes™, a Regal Rexnord™ brand, joined local partner Renewable Parts Ltd to resurface the damaged yaw brake disc uptower. Inside the turbine's nacelle, one of the yaw brake calipers was removed and replaced with a specialized measuring tool to check the extent of the damage, including depth, runout and overall flatness of the turbine's yaw brake disc. A Svendborg Brakes DRT gen2 tool was mounted to mill the damaged disc surface. Once the surface was milled back, the brake pad contact area was repaired, and the removed caliper was reattached. The complete yaw brake disc system was tested to ensure that it met Regal Rexnord quality standards and fulfilled the customer's needs.
