# AllTorque

THE LATEST NEWS FROM  
TWIFLEX, WICHITA, BIBBY,  
STIEBER (UK) & STROMAG (UK)

## Twiflex Unit Refurbishment

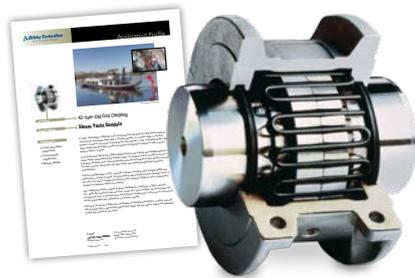
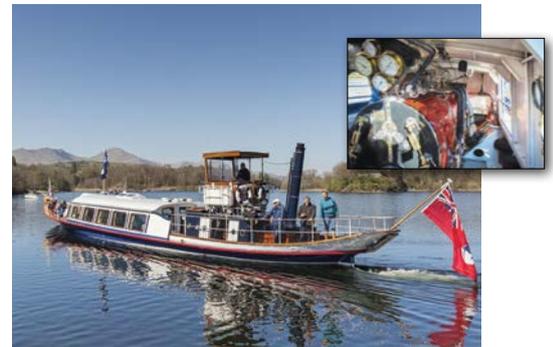
Upon viewing the photos, a Bibby engineer identified the coupling as a Type C and Size 212. While the coupling's hubs and cover remained in good condition, the gridmember was corroded and worn. It has since been found that the coupling was not the source of the knock, but the gridmember was replaced as a precaution anyway.

Over four decades later in 2022, operators noticed a knocking noise at higher RPMs, and shortly after a change of speed. The grid coupling was suspected to be a possible source of the noise. The boat's manager sent photos of the coupling to Bibby for help in determining whether he needed to replace the coupling.

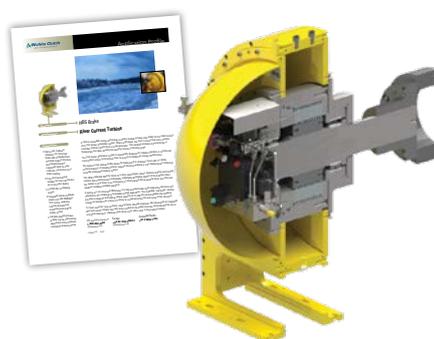
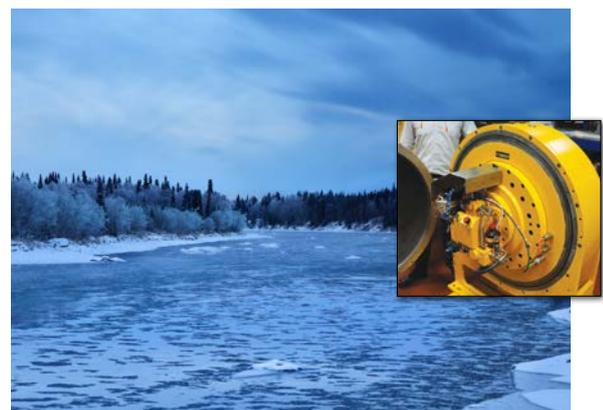
A spring-set, oil-immersed HBS brake in a fully enclosed water tight supporting structure was selected for this challenging renewable energy application. The multiplate 'wet brake' solution provides a stopping and holding torque capacity of 27,000 Nm and dissipates the stopping energy by transfer into a store of cooling oil contained within the sump of the structure.

To meet customer 'plug and play' requirements, Wichita engineers also developed an integrated HPU and control module that is close coupled to the brake structure and protected by a stainless steel dome cover.

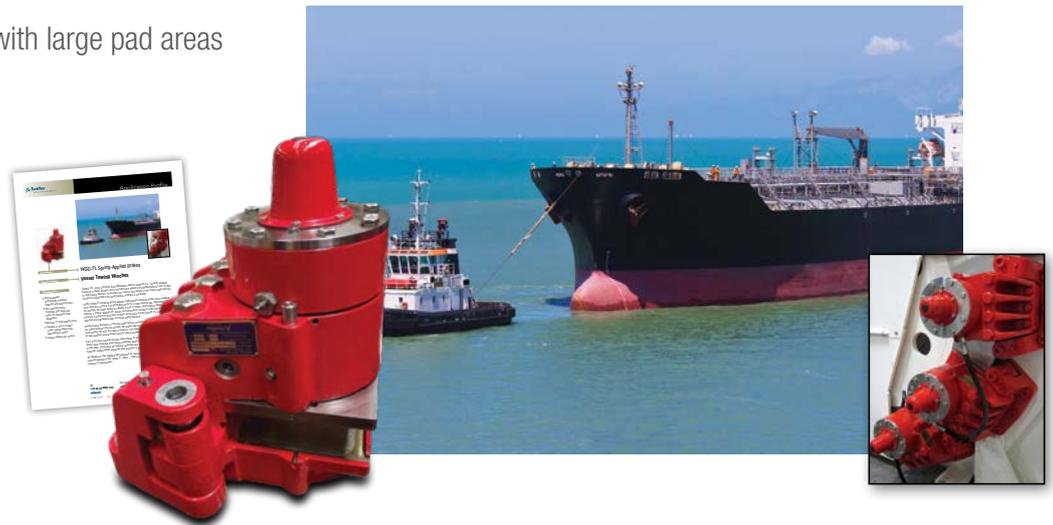
Twiflex VKSD-FL (floating) spring-applied, hydraulically-released brakes were supplied, each rated at 119 KN braking force for a 2mm pad air gap.

- Each of the two onboard winches utilize VKSD-FL brakes acting on a 1500mm dia. x 40mm thick extended drum flange
- Unique 'parked-off' feature
- Non-asbestos lining materials with large pad areas for maximum heat dissipation

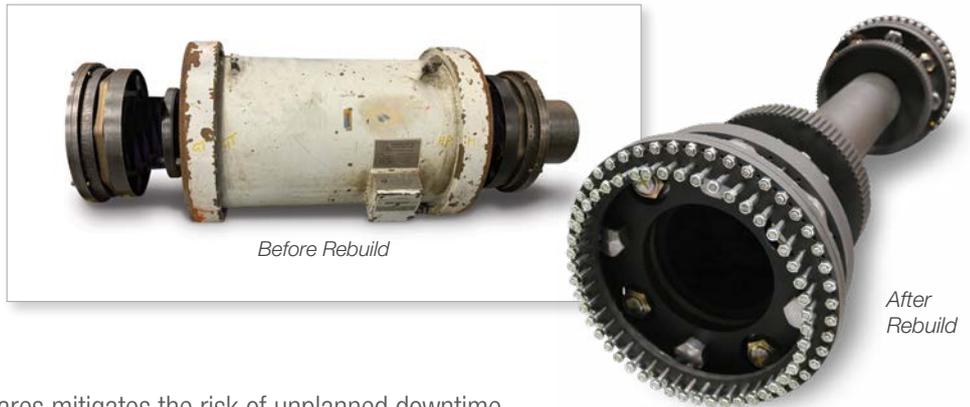
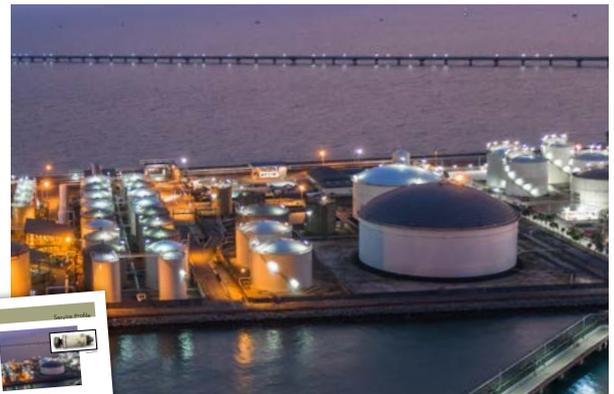
In this case the customer holding local spares mitigates the risk of unplanned downtime by providing a readily available alternative, when crucial operating equipment must be removed from service. The Bibby high performance 305S Torquemeter disc coupling, installed between a gas turbine and a high speed compressor had been in service for more than 23 years. Perhaps worn or damaged by corrosion or contamination, or from operation in an exceptionally harsh environment, it was removed from operation and substituted by the ready-to-use replacement, then returned to the Bibby team for a health check and any necessary refurbishment.

Within two weeks of its arrival at Bibby's Bedford, UK facility, the coupling was disassembled and removed from the bearing casing, and within six weeks, it was on its way back to the customer as a fully working refurbished coupling.

- To determine the extent of this requirement, the process begins with complete strip down and inspection.
- A summary report is generated documenting all the remedial work (and replacement components) required.
- All hardware items are replaced as a matter of course (including the disc packs, shims and fittings).
- MPI inspection of critical components (i.e. those in the torque path) ensure that even hidden damage is identified and addressed.
- Application of the appropriate protective coatings.
- Balancing of the rebuilt coupling is carried out according to the original specification.
