## Custom Bearing Assembly

## Garment Racks for Trucks

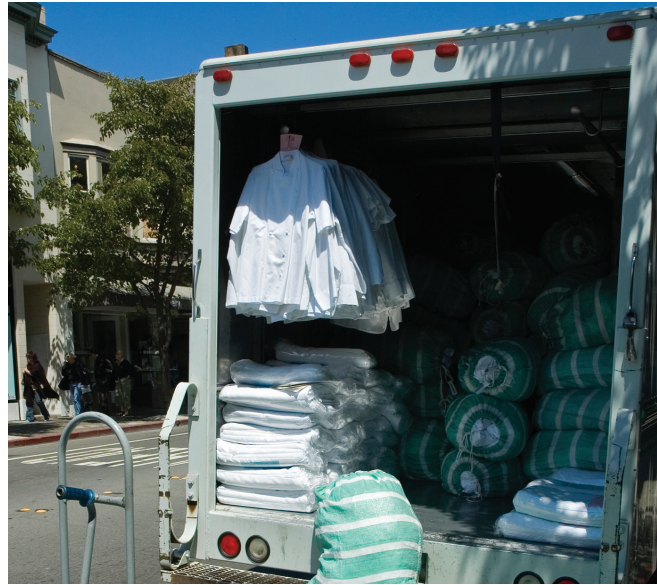
- Custom, double-row bearing assembly
- Integrated set screw to ensure proper alignment
- Engineered plastic selected for long life

After careful review of the application, Kilian engineers quickly designed a custom, double-row ball bearing assembly integrated into a housing made with an engineered plastic selected for durability. The key feature that impressed the customer was an integrated set screw which ensures proper alignment to the rack arms, smooth rolling performance, and easy, quick maintenance.

A regional conveyor OEM needed a bearing solution to replace failing bearings on their rack systems used in garment/uniform delivery trucks. The failures occurred because the solid plastic roller/bushing very quickly became worn and began to fail in the field. Repair of the current design required a very time-consuming disassembly of the system that also forced some system components to be scrapped. The frantic customer approached Kilian for help in solving the problem which was becoming a major repair expense and a source of customer dissatisfaction.

Even though the new bearing design was more expensive than the original plastic bushing, the customer will save many thousands of dollars per year in repair and maintenance costs with the customized, value-added Kilian design solution.
