Product

Worm Gear Drives

Application

Screwdown Mill Stands

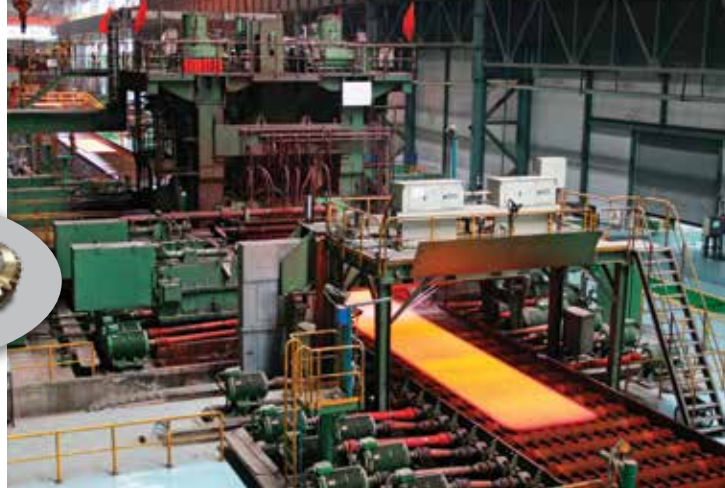
A large steel mill in Pennsylvania was experiencing continuous problems with the gear drives in their screwdown mill stands. The existing manufacturer's gear material was breaking down which caused fatiguing, cracks and broken teeth due to inherent designed duty-cycle stresses.

The Delroyd team reverse-engineered the screwdown gearbox to develop a more robust solution. The bronze gear material was changed to manganese for enhanced yield and overall strength. A larger radius and shot peen process was added to the root of the worm thread hence reducing the root stresses.

- Large radius added to worm thread
- Manganese gear material for enhanced yield and strength
- Through hardened, ground and polished alloy steel worm
- Worm thread root was shot peened to provide stress reduction at contact zone

The new Delroyd gearbox design extended the gearing life from 3 years to more than 6 years. Based on the redesigned mill stand gear box success, the customer awarded Delroyd with orders for additional new complete gearboxes, spare worm/gear sets and additional gearbox rebuilds.
