## Product

## Worm Gear Sets

## Application

## Screwdown Mill Stands

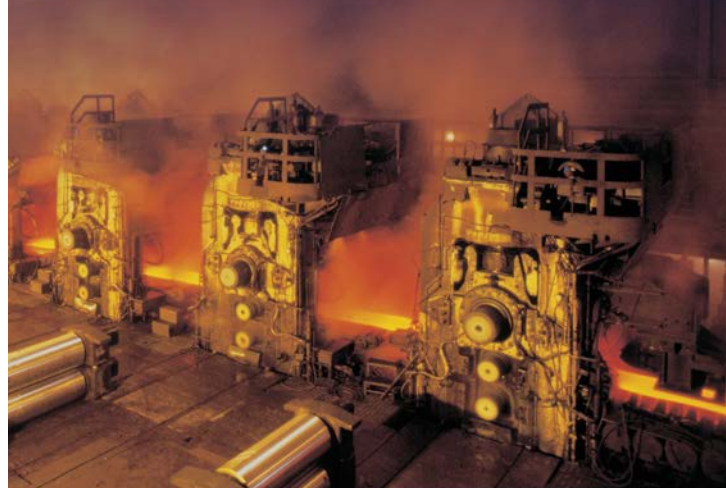
Screwdown mill stands gear drives at a major steel mill in Ohio were failing prematurely causing extensive downtime. The worm gear teeth were wearing and breaking down at an accelerated rate due to improper meshing at the contact zone. The problem created excessive pressure at the gear's pitch line/contact zone.

Delroyd engineers met with the hot mill managers to conduct an on-site inspection and short-term mill stand monitoring period. Through these efforts, it was determined that the cause of the drive failures was that three different gearing manufacturers had supplied gearing, all with different thread designs, which were being mixed and matched over time.

A spare worm and gear sample was sent to the Delroyd facility so that a new gearing solution could be reverse-engineered to ensure that all gear sets installed on the hot mill stands would have a matching thread/tooth design. The new Delroyd gearing solution extended the gearing life from 6 months to more than 6 years.
