## Genuine Wichita Replacement Wear Plate

### Steel Mill

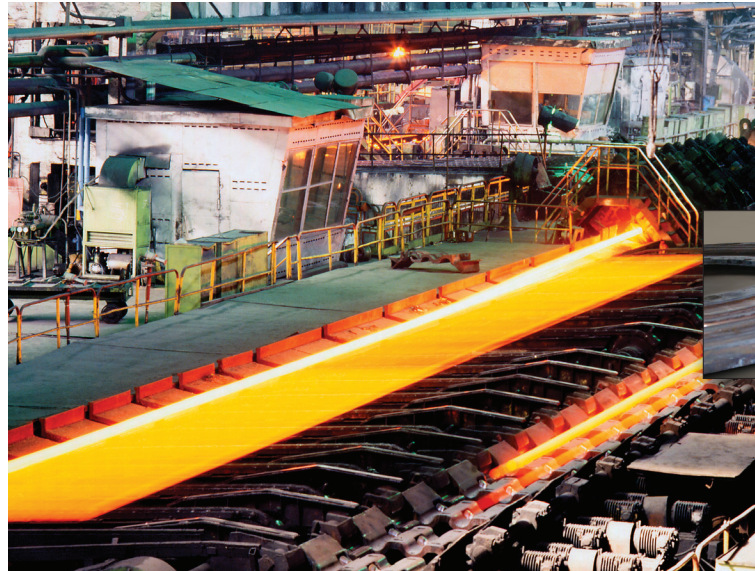
Severe damage on non-genuine copper wear plate

In an attempt to save a small amount in maintenance costs, a metal processing mill in Malaysia chose to install a non-genuine replacement copper wear plate in a Wichita Kopper Kool clutch. After a short period in service, the production line had to be shut down since the braking system developed a serious coolant leak and started overheating. Further investigation showed that the unauthorized copper plate had become distorted and suffered from serious wear that led to the leaks.

The mill's maintenance manager eventually replaced the bad wear plate with a genuine Wichita replacement plate. All replacement Wichita Clutch brand copper wear plates are precisely matched with mating Wichita clutch and brake components for optimum performance and ease of installation.
