A. Replacing the Brake Assembly

B. BBC Burnish Instructions

C: Troubleshooting the Warner Electric BBC

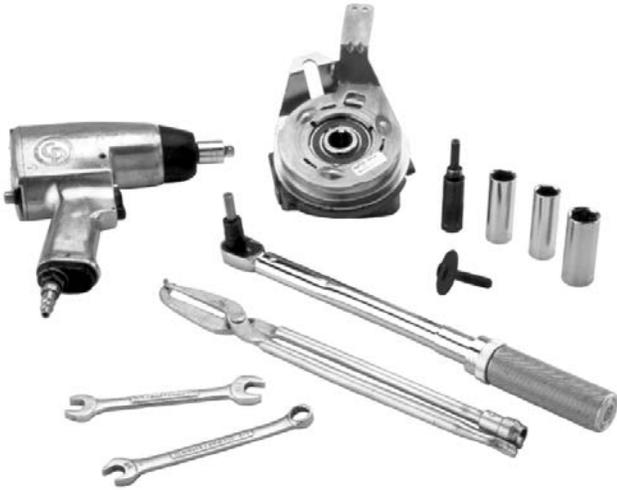
1. Remove the lawn mower blade from the BBC by removing the blade mounting bolts.
2. Remove the BBC mounting bolt.
3. Disconnect the customer supplied brake actuation spring.
4. Disconnect the BBC actuation cable.
5. Remove anti rotation bolt pin if necessary.
6. Remove the BBC assembly from the mower.

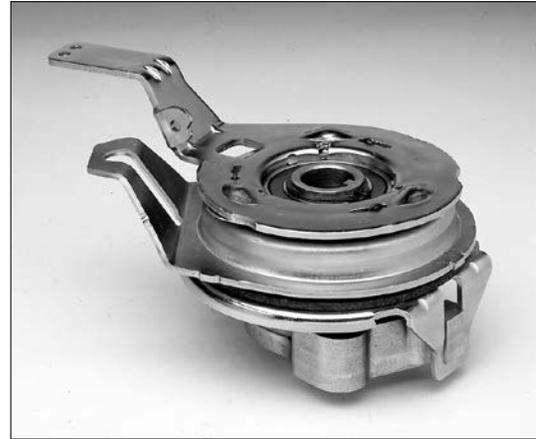
NOTE: Pin must be free of grooves that will prevent axial movement of the brake plate.

Note: On some applications, the BBC brake assembly will not easily fit through the space allowed in the mower deck. In this instance, the mower engine mounting bolts must be removed and the mower engine lifted off of the deck so that the brake assembly can be removed.

7. Install the new BBC brake assembly directly to the engine crankshaft. In the case where the mower engine was lifted up, remount the engine to the mower deck.
8. Reinstall the BBC actuation cable.
