Oldham Couplings

FORKLIFT STEERING COLUMNS

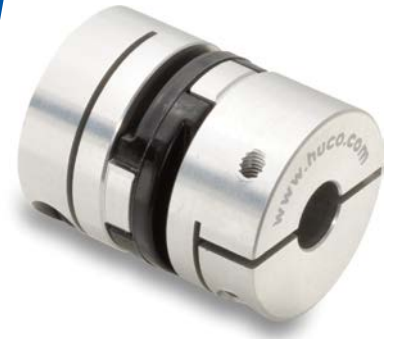
As a leading manufacturer of precision couplings, Huco Dynatork is renowned for its Oldham style line. The Oldham style design transmits torque through a central disc that slides over the tenons on the hubs under controlled preload conditions. This eliminates backlash and protects against shock loading – which is perfect for steering applications. Reliable Huco Oldham style couplings are manufactured using high quality materials with strict in-house testing and monitoring.

- Aluminum alloy hubs with standard acetal torque discs
- Eliminates backlash and protects against shock loading
- Strict in-house testing and monitoring
- Through-bored variant available for faster disc replacement
- Available in different materials for easy configuration to meet different application performance requirements
