Custom Bearing Assembly

EXCAVATOR TENSIONER PULLEY

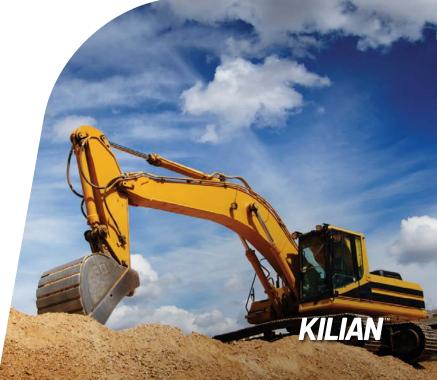
After carefully reviewing the application, Kilian engineers created a unitized bearing design that eliminated the need to buy and assemble other components and made installation much simpler, eliminating scrap due to brinelling.
