# SVENDBORG BRAKES RESURFACING IMPROVES YAW BRAKE PERFORMANCE

# SVENDBORG BRAKES RESURFACING IMPROVES YAW BRAKE PERFORMANCE ON ORE CATAPULT'S TEST TURBINE IN SCOTLAND

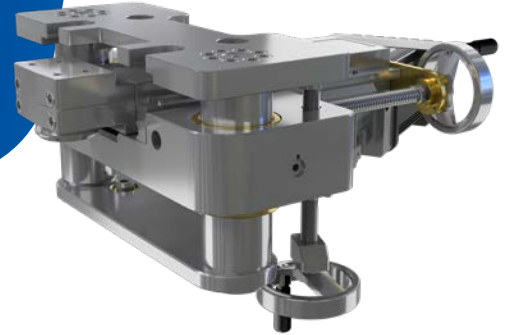
Engineers from the Wood Group identified a damaged yaw brake disc on the Offshore Renewable Energy (ORE) Catapult's Samsung 7MW wind turbine based in Levenmouth, on the east coast of Scotland. The damaged disc was causing increased and uneven wear on the brakes' caliper pads, forcing turbine operations and maintenance specialists to purchase new pads and replace them more frequently.

Experts from Svendborg Brakes™, a Regal Rexnord™ brand, joined local partner Renewable Parts Ltd to resurface the damaged yaw brake disc uptower. Inside the turbine's nacelle, one of the yaw brake calipers was removed and replaced with a specialized measuring tool to check the extent of the damage, including depth, runout and overall flatness of the turbine's yaw brake disc. A Svendborg Brakes DRT gen2 tool was mounted to mill the damaged disc surface. Once the surface was milled back, the brake pad contact area was repaired, and the removed caliper was reattached. The complete yaw brake disc system was tested to ensure that it met Regal Rexnord quality standards and fulfilled the customer's needs.

- Svendborg Brakes DRT gen2 tool remilled the damaged disc surface.
- The turbine nacelle did not need to be removed to resurface, resulting in a major cost savings.
- Remilling discs on-site significantly lowers downtime, maintenance costs, and environmental impact.
