# Air Conditioning Clutch

## Troubleshooting Guide

P-1011-WE  
819-0505

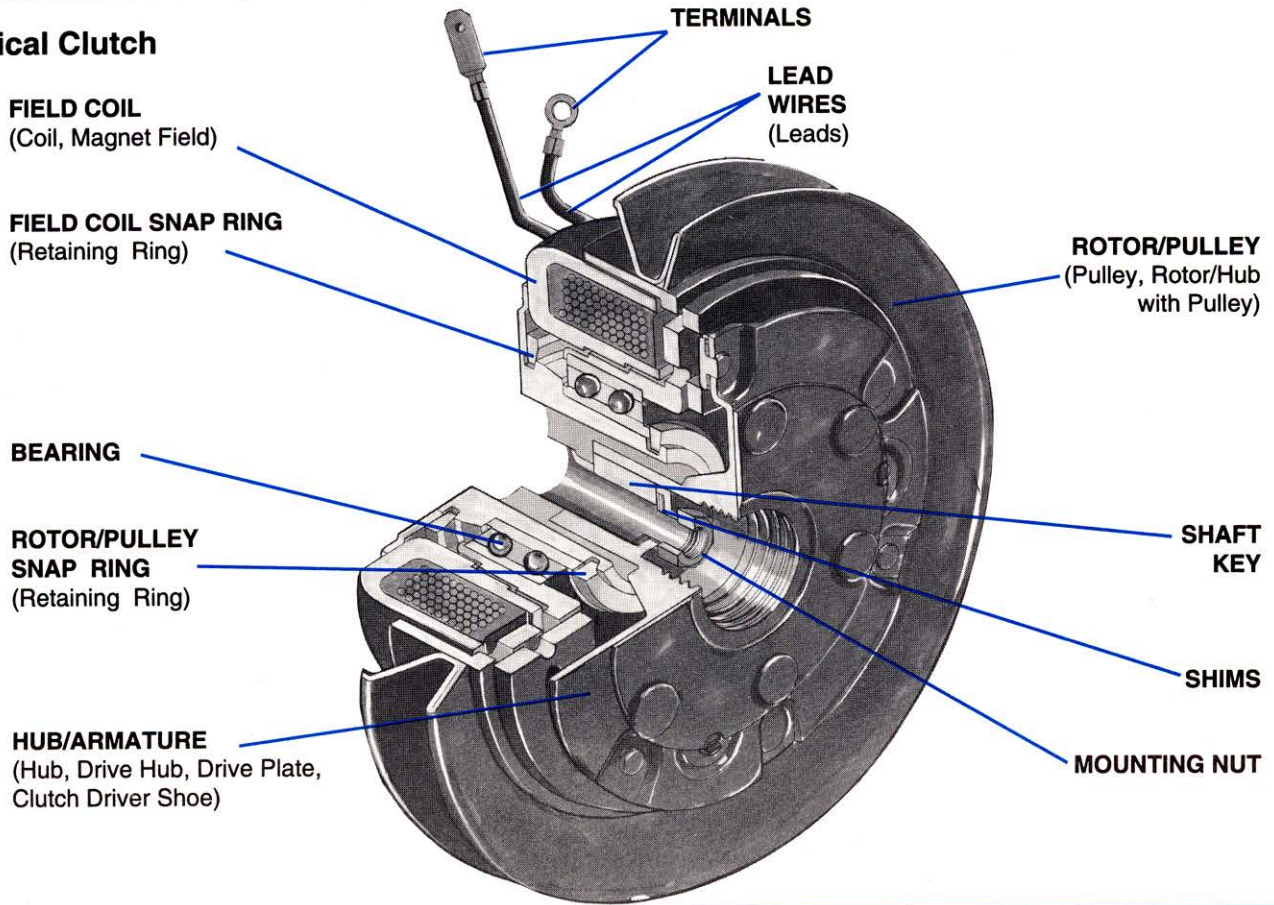
## Typical Clutch

The following illustration shows cutaways of a Typical Clutch and World Clutch. The component names used in this guide are in bold on the illustration. Common names are listed in brackets under the component names.

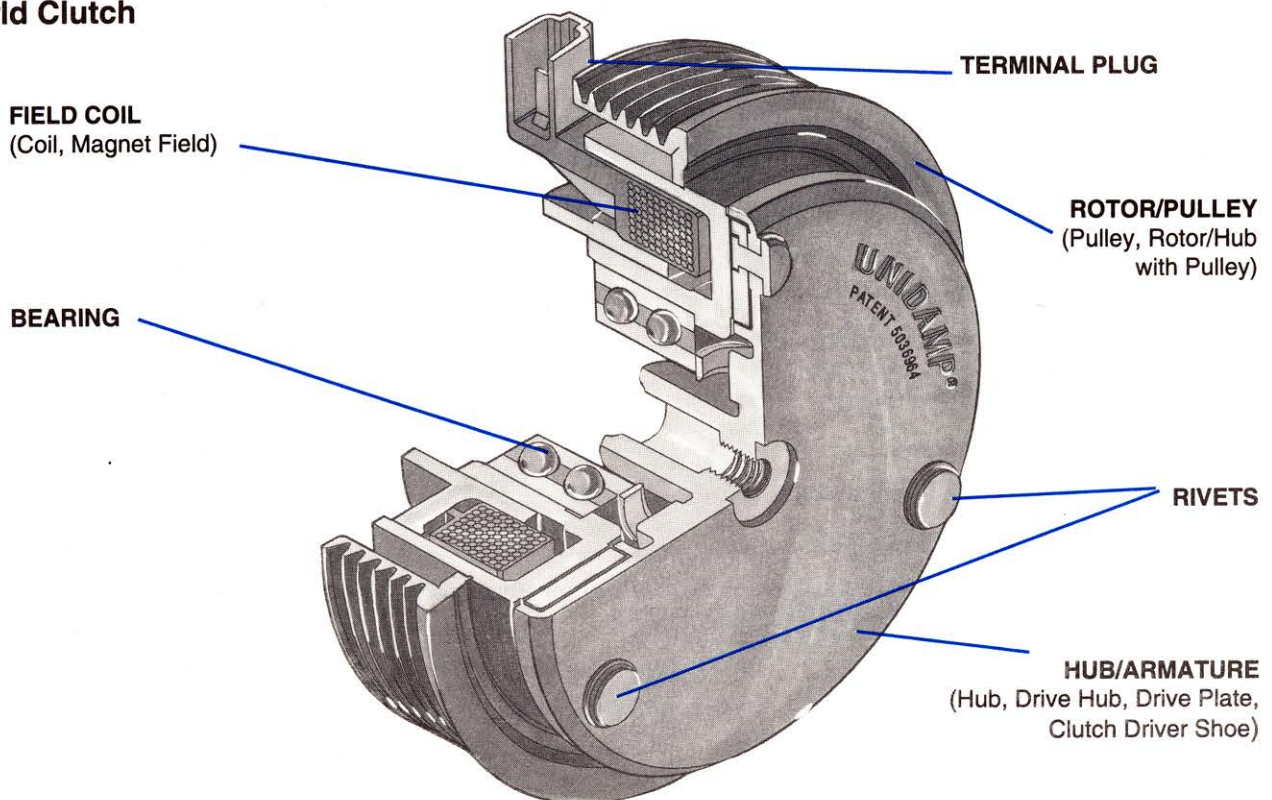
## World Clutch

Two types of clutches are covered in this manual, "typical" clutches and Warner Electric's World Clutch. The troubleshooting sequences which follow apply equally to both types, except where noted as World Clutch only. These sections are darkened to easily distinguish them. Since the World Clutch is significantly different from "typical" clutches, a separate cutaway view is offered on page 3.

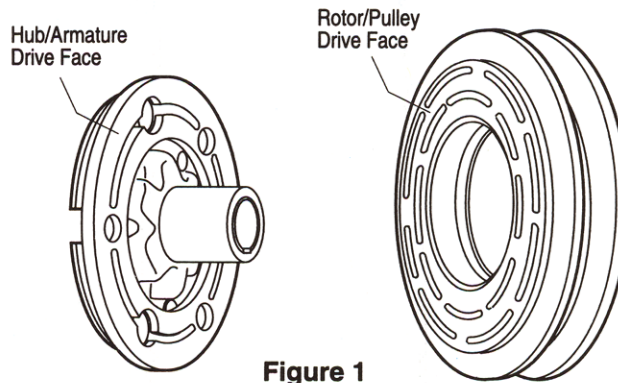
Figure 1

Is oil or grease on the clutch or on the hub/armature and rotor/pulley drive faces? See Figure 1.

- A. Compressor shaft seal leak.
- B. Compressor through-bolt leak.
- C. External oil source, such as engine oil, power steering fluid, etc.

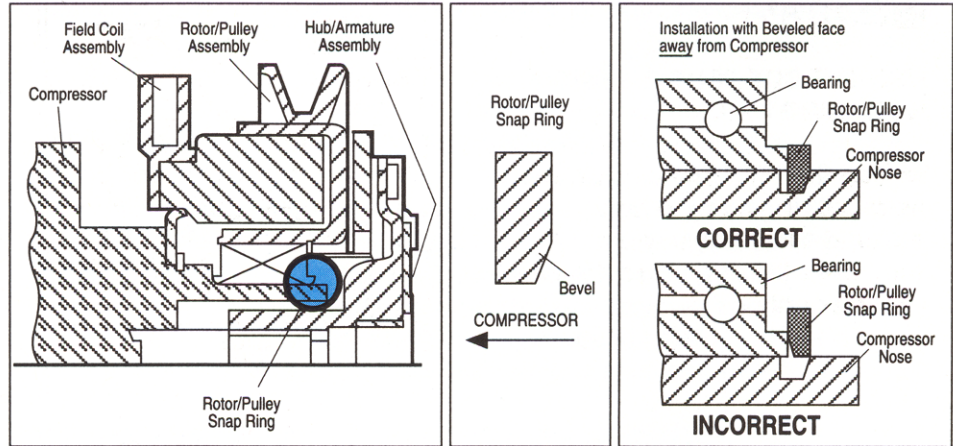
**Figure 2**

Remove the hub/armature. Is the rotor/pulley snap ring missing or improperly installed? See Figure 2.

**A**  
Location of Rotor/Pulley Snap Ring

**B**  
Rotor/Pulley Snap Ring Bevel

- The bevel on the rotor/pulley snap ring **MUST** face away from the compressor. See Figures 2A, B, C.
- The rotor/pulley snap ring must be seated fully in the groove. See Figure 2C.

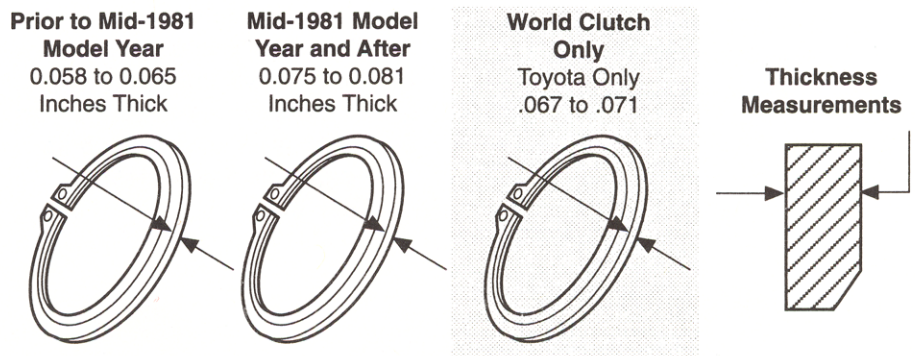
**Figure 3**

Is the field coil snap ring the correct ring? See Figure 3. Is it installed correctly? See Figure 4, page 6.

During the 1981 model year, the field coil ring used to hold the field assembly in place was made thicker. (Ford FS-6 and Chrysler only).

Be sure to use the correct field coil snap ring. See Figure 3.

**NOTE:** Check the compressor for anti-rotation pin damage. Repair or replace compressor as required. Replace clutch if damaged. Be sure to use the correct field coil snap ring. See Figure 3.

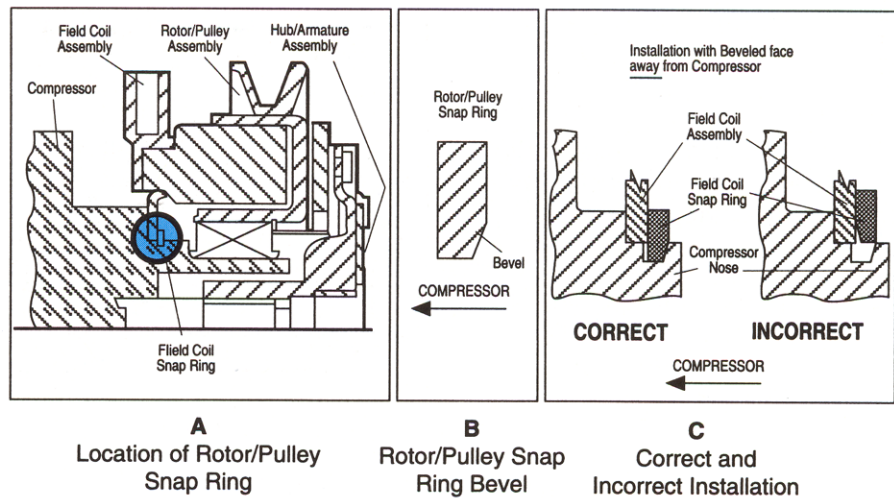
**Figure 4**

### USE THE CORRECT RETAINING RING

During the 1981 model year, the field coil ring used to hold the field assembly in place was made thicker. (Ford FS-6 and Chrysler only).

- The bevel on the field retaining ring **MUST** face away from the compressor. See Figures 4A, B, C.
- The field retaining ring must be seated fully in the groove. See Figure 4C.
- The lug of the field retaining ring must **NOT** be positioned over the anti-rotation pin. See Figure 7.
- The field must be tight against the compressor.

- The bevel on the field coil snap ring **MUST** face away from the compressor. See Figures 4A, B, C, page 5.
- The field coil snap ring must be seated fully in the groove. See Figure 4C, page 5. A typical indicator of improper field coil snap ring installation is rubbing between the field coil and rotor/pulley poles. See Fig.5 Also, if the field coil has an anti-rotation hole, the hole may be elongated or deformed from beating against the anti-rotation pin. See Figure 6.
- The lug of the field coil snap ring must **NOT** be positioned over the anti-rotation pin. See Figure 7.
- The field coil must be tight against the compressor. (Meaning the field coil cannot be rotated by hand or moved axially on the compressor).

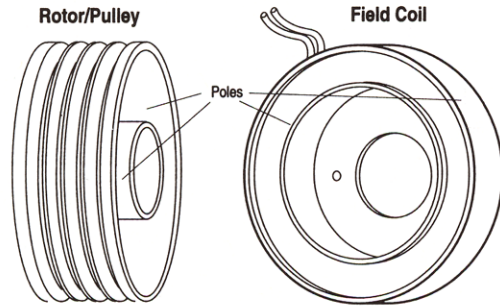
**Figure 5**

A typical indicator of improper field coil snap ring installation is rubbing between the field coil and rotor/pulley poles. See Figure 5. Also, if the field coil has an anti-rotation hole, the hole may be elongated or deformed from beating against the anti-rotation pin. See Figure 6.

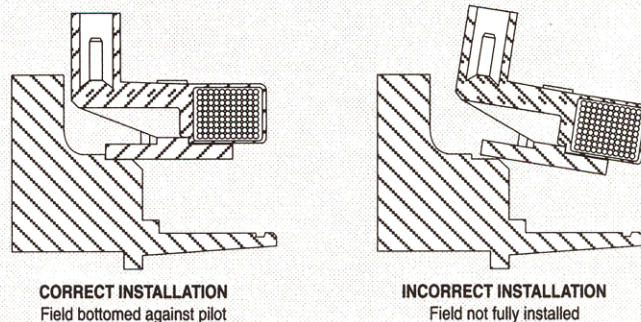
**Figure 7a**  
**Ford FX15 Compressor**

Is field assembly installed correctly? See Figure 7a for field assembly correctly bottomed onto pilot shoulder.

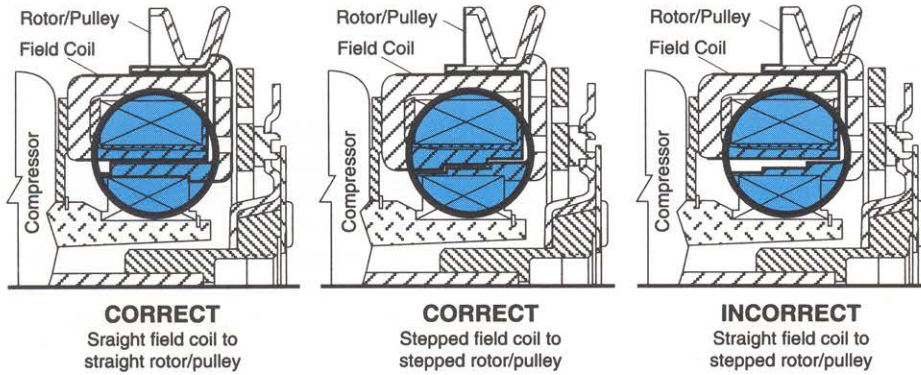
**Figure 8**

Are the clutch components mismatched? See Figure 8.

**ALWAYS** replace rotor/pulleys and hub/armatures in pairs.  
**NEVER** mix new and used rotor/pulleys and hub/armatures or clutch failure may result.

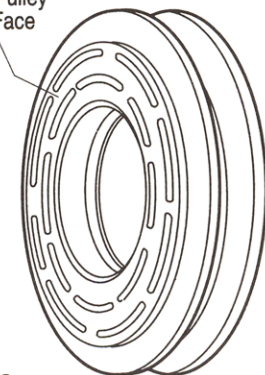
**Figure 9**

Is oil or grease on the clutch or on the hub/armature and rotor/pulley drive faces? See Figure 9.

Rotor/Pulley Drive Face

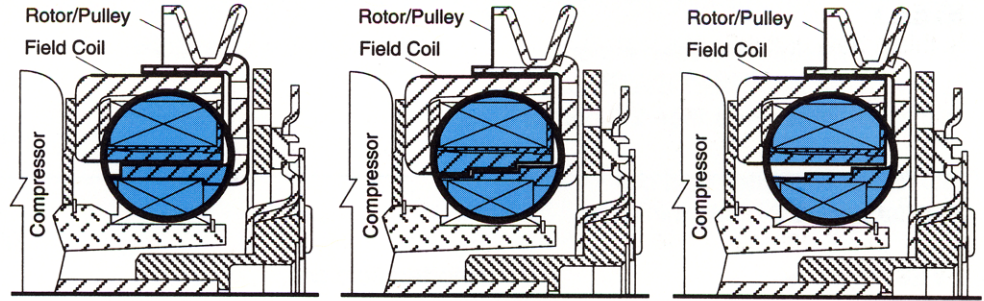
**Figure 10**

Are the clutch components mismatched? See Figure 10. NOTE: World Clutch field and rotors will not physically fit with the previous model field and rotor components.

**CORRECT**  
Straight field coil to straight rotor/pulley

**CORRECT**  
Stepped field coil to stepped rotor/pulley

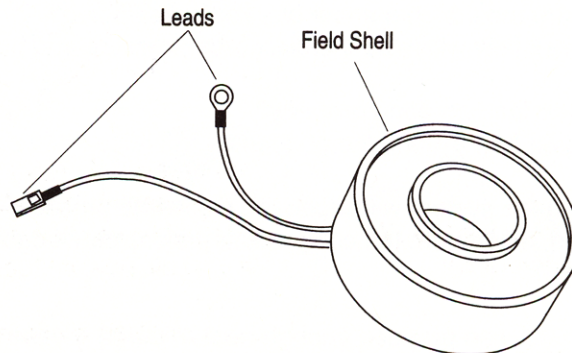
**Figure 11**

Check resistance of the field coil between both leads. See Figure 11. Is the resistance less than 2.0 ohms?

NOTE: World clutch field coil resistance is 3.2 ohms minimum.

INSPECTION	PRIMARY CAUSE(S)	CORRECTIVE ACTION
<p><b>STEP 7</b> Is there continuity between either lead and the field shell? See Figure 11. Is the resistance less than 2.0 ohms?</p> <p>NOTE: World Clutch field coil resistance is 3.2 ohms minimum.</p> <p><b>YES.</b> —————&gt;</p> <p><b>NO.</b> Proceed to STEP 8.</p>	<p>Shorted field coil.</p>	<p>Replace field coil.</p>

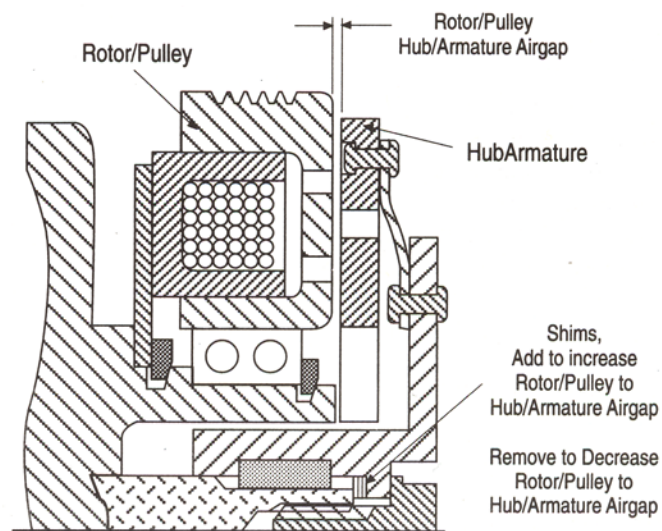
**Figure 12**

**STEP 3**  
Disconnect the field coil electrical connections and rotate the rotor/pulley. Is the hub/armature dragging on the rotor/pulley? See Figure 12

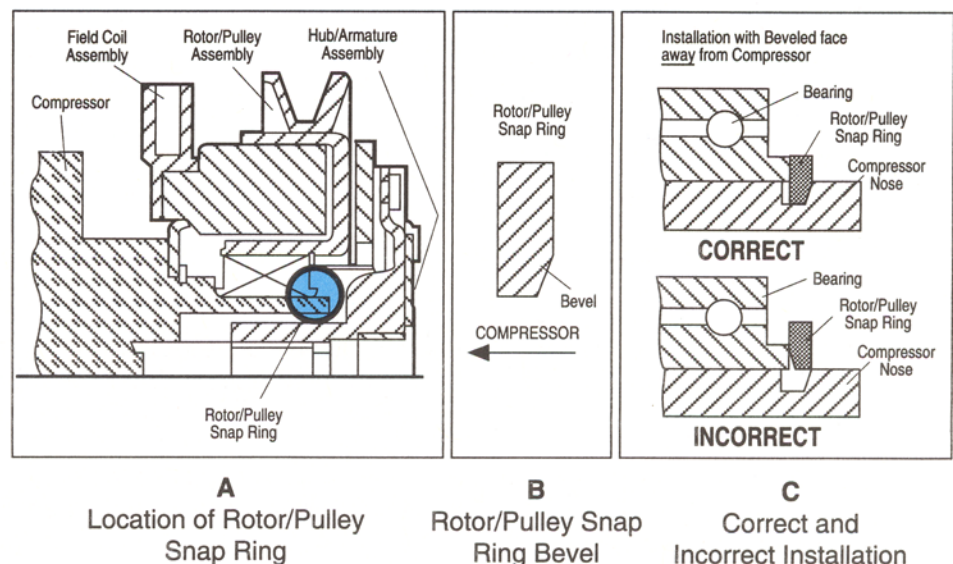
**Figure 13**

**STEP 4**  
Remove the hub/armature. Is the rotor/pulley snap ring missing or improperly installed. See Figure 13.

INSPECTION	PRIMARY CAUSE(S)	CORRECTIVE ACTION
<p>YES. →</p>	<p>The rotor/pulley snap ring was not installed or was improperly installed.</p>	<p>Replace clutch if damaged. Repair or replace compressor as required.</p> <p><b>IMPORTANT</b> The bevel on the rotor/pulley snap ring <b>MUST</b> face away from the compressor. See Figures 13A, B, C.</p> <p>The rotor/pulley snap ring must be seated fully in the groove. See Figure 13C.</p>
<p>NO. →</p>	<p>Rotor/pulley to hub/armature air gap too small.</p>	<p>Reset the hub/armature to rotor/pulley air gap to 0.020 to 0.040 inch clearance by removing shims. World Clutch with Unidamp® Armature air gap settings are: New .018" to .030" and Used .013" to .025". See Figure 12. Measure the air gap between the hub/armature and rotor/pulley at three locations 120° apart using a feeler gage.</p>

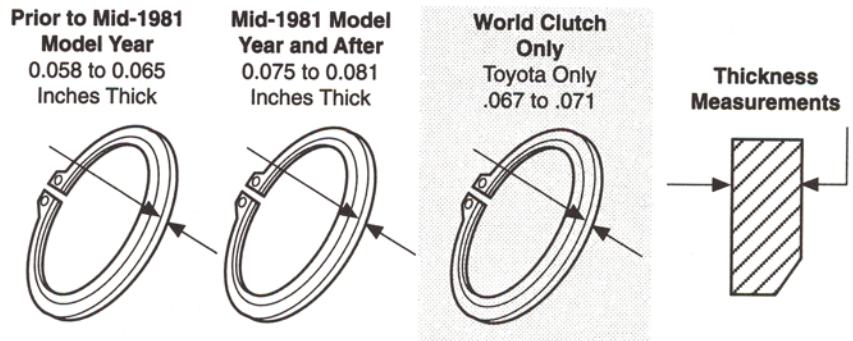
Figure 14

Is the field coil snap ring the correct ring? See Figure 14. Is it installed correctly? See Figure 15C.

### USE THE CORRECT RETAINING RING

During the 1981 model year, the field coil snap ring used to hold the field coil assembly in place was made thicker. (Ford FS-6 and Chrysler only.)

Replace clutch if damaged.  
 ⚠ Be sure to use the correct field coil snap ring. See Fig. 14, page 13.  
 Repair or replace compressor as required.

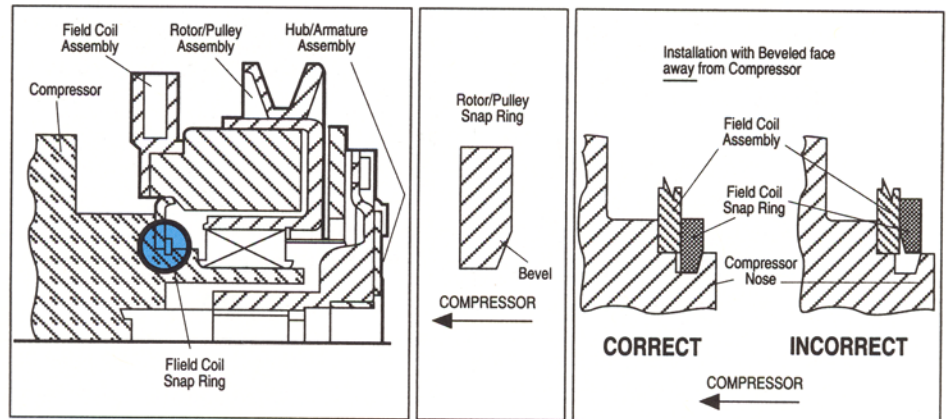
Figure 15

**A**  
Location of Rotor/Pulley Snap Ring

**B**  
Rotor/Pulley Snap Ring Bevel

- IMPORTANT**
- The bevel on the field coil snap ring **MUST** face away from the compressor. See Figures 15A, B, C, page 13.
  - The field coil snap ring must be seated fully in the groove. See Figure 15C, page 13. A typical indicator of improper field coil snap ring installation is rubbing between the field coil and rotor/pulley poles. See Fig. 16
  - Also, if the field coil has an anti-rotation hole, the hole may be elongated or deformed from beating against the anti-rotation pin. See Figure 17.
  - The lug of the field coil snap ring must **NOT** be positioned over the anti-rotation pin. See Figure 18.
  - The field coil must be tight against the compressor (meaning the field coil cannot be rotated by hand or moved axially on the compressor).

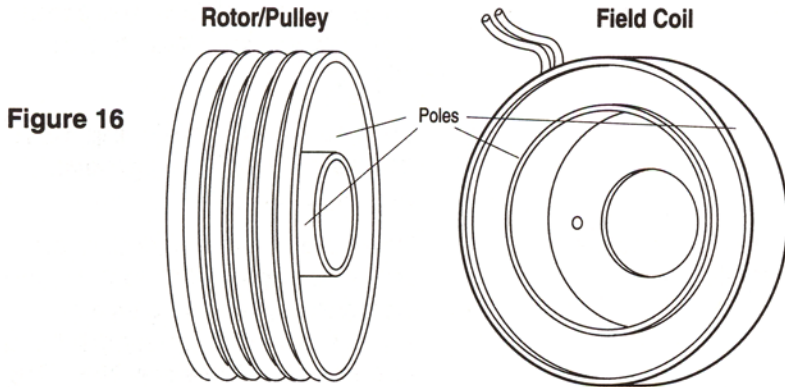
Figure 16

- A. Wrong field coil snap ring.
- B. Field coil snap ring installed incorrectly.

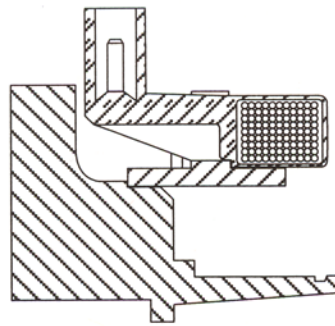
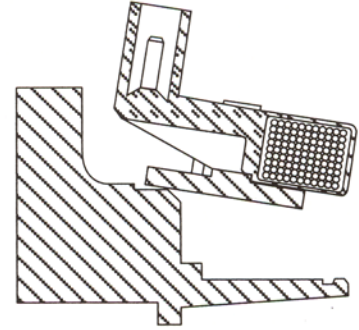
**Figure 18a**

**CORRECT INSTALLATION**  
Field bottomed against pilot

**INCORRECT INSTALLATION**  
Field not fully installed

Is field assembly installed correctly? See Figure 18a for field assembly correctly bottomed onto pilot shoulder.

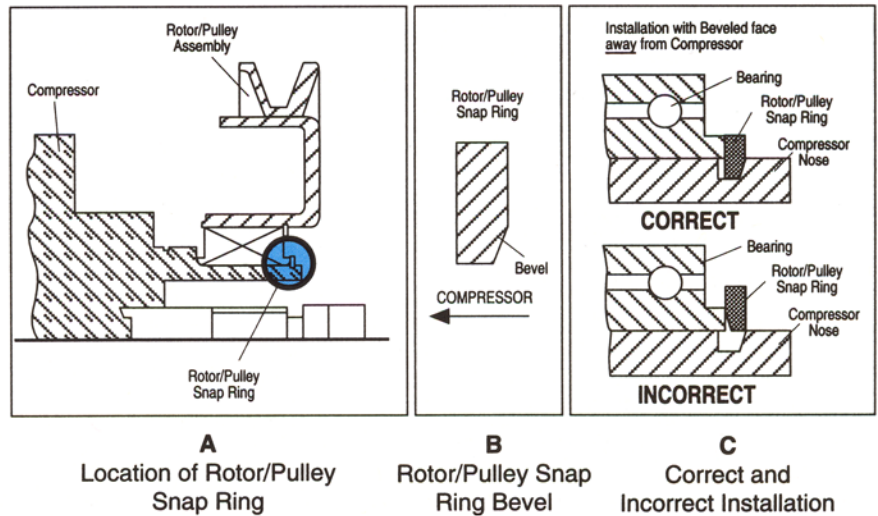
**Figure 19**

**⚠** Be sure to install the rotor/pulley snap ring. See Figure 19. Idle the engine and listen for noise. Does the noise continue?

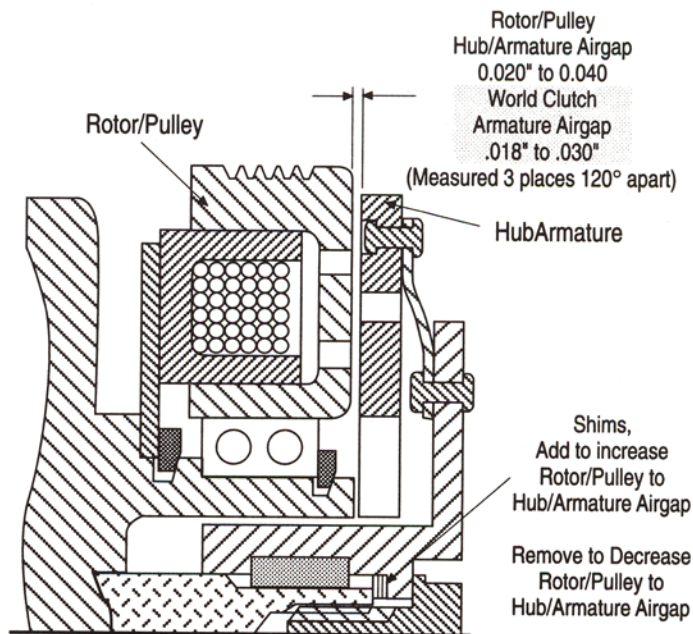
Figure 20

Check the hub/armature to rotor/pulley air gap. Does it exceed 0.125 inches? See Figure 20.

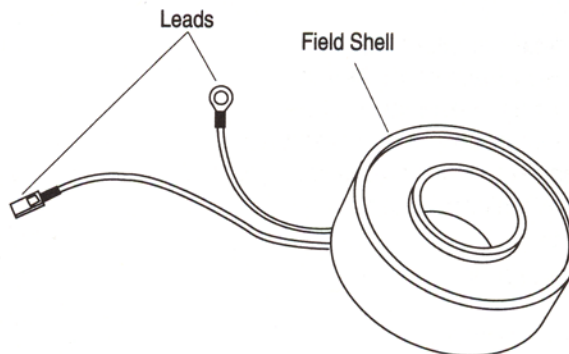
**Figure 21**

Check resistance of the field coil between both leads. See Figure 21. Is the resistance less than 2.0 ohms (or 3.2 ohms for a World Clutch field coil)?

Is there continuity between either lead and the field shell? See Figure 21.

Is there continuity between the field coil leads? See Figure 21.

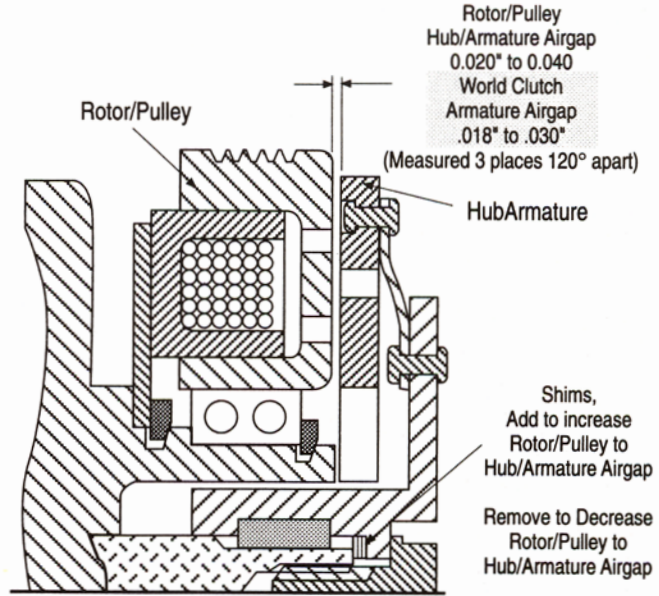
Figure 22

Disconnect the field coil electrical connections. Check the rotor/pulley to hub/armature air gap. See Figure 22. Is there a minimum of 0.020 inch clearance between the hub/armature and the rotor/pulley? World Clutch with Unidamp® armature has .010" minimum airgap.

INSPECTION	PRIMARY CAUSE(S)	CORRECTIVE ACTION
NO. —————>	The hub/armature to rotor/pulley air gap is too small.	Reinstall the armature and set the hub/armature to rotor/pulley air gap to 0.020 to 0.040 inch clearance by adding shims. World Clutch with Unidamp armature airgap settings are New .018" to .030" and Used .013 .025". See Figure 22. Measure the air gap between the hub/armature and rotor/pulley at three locations 120° apart using a feeler gauge.

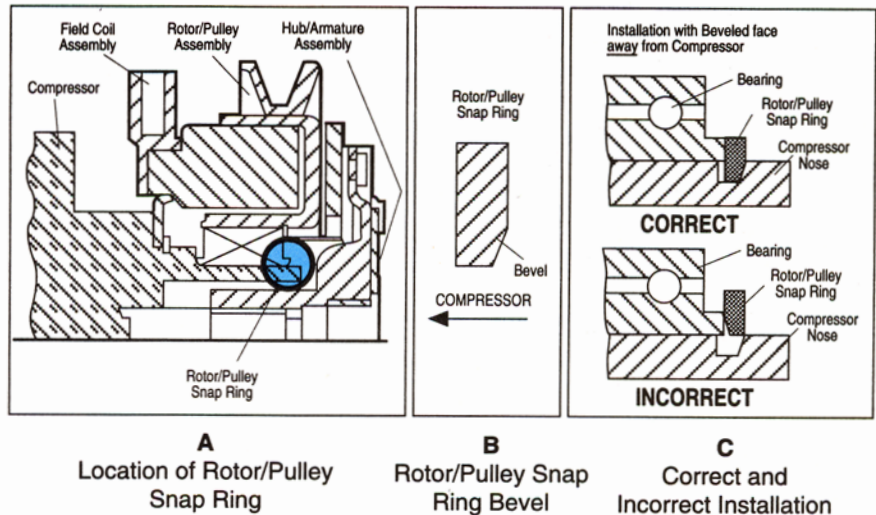
Figure 23

Remove the hub/armature. Is the rotor/pulley snap ring missing or improperly installed? See Figures 23.

- The bevel on the rotor/pulley snap ring **MUST** face away from the compressor. See Figures 23.
- The rotor/pulley snap ring must be seated fully in the groove. See Figure 23C.
- World Clutch with Unidamp® armature average airgap setting is:  
New: .018" to .030"  
Used: .013" to .025"
