MagStop Splash Guard Bearing Protection

Splash guards offer supplemental bearing protection designed to prevent water ingress from power washing and other severe environments

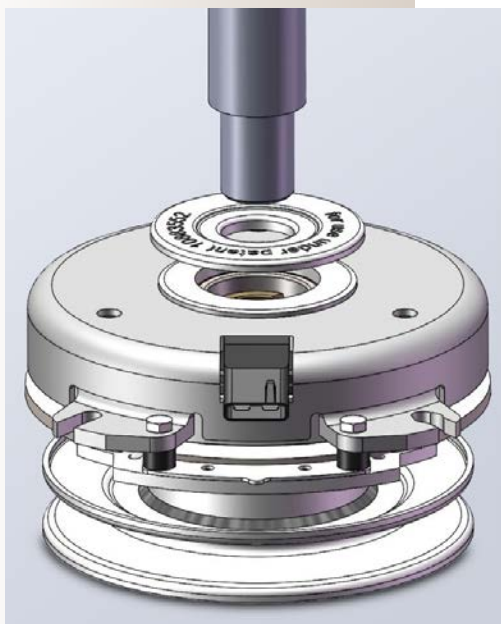
The splash guard is installed between the crank shaft or ground drive hub shoulder and the inner race of the clutch top bearing.

The use of splash guards has demonstrated significant reduction in bearing contamination and improves bearing life. Multiple configurations have been designed for use with various frame, bearing and bore combinations.
