HIGH PERFORMANCE NON-LUBRICATED COUPLING SERVICE LIFE AND FAILURE MODES

By James H. Paluh, Manager-Engineering, High Performance Products
Ameridrives International, December, 1997

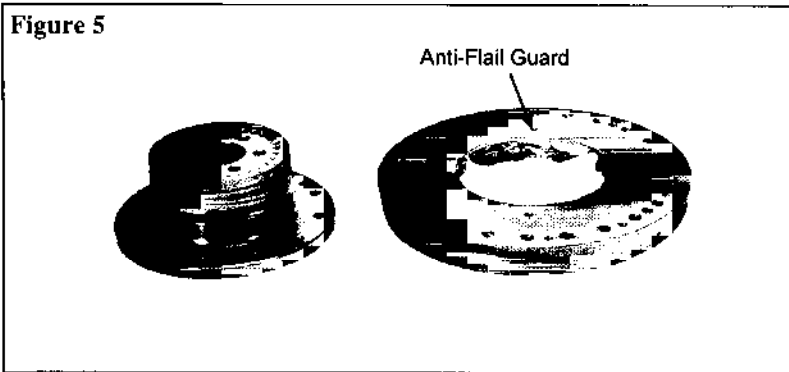
Figure 5

The instantaneous loss of load will result in standard turbomachinery overspeed trip. After shear failure, the Ameriflex coupling's anti-flail guards contain the center section for safety and protect the adjoining equipment (**Figure 5**).
