BBC Clutch Installation

P-2110-WE
819-0375

Installation Instructions

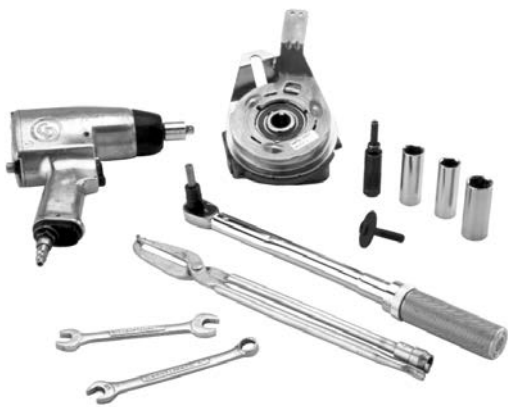
A. Replacing the Brake Assembly

1. Remove the lawn mower blade from the BBC by removing the blade mounting bolts.
2. Remove the BBC mounting bolt.
3. Disconnect the customer supplied brake actuation spring.
4. Disconnect the BBC actuation cable.
5. Remove anti rotation bolt pin if necessary.
6. Remove the BBC assembly from the mower.

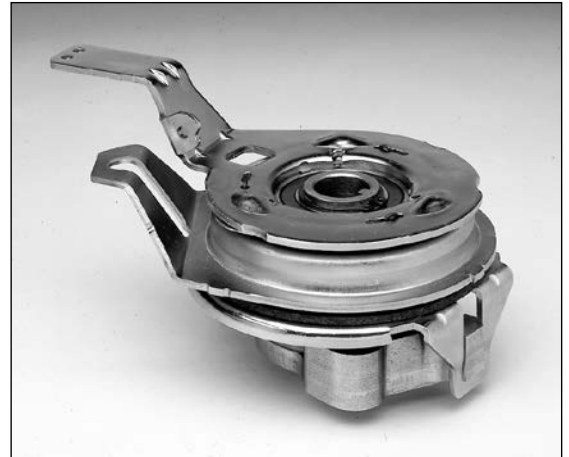
Note: On some applications, the BBC brake assembly will not easily fit through the space allowed in the mower deck. In this instance, the mower engine mounting bolts must be removed and the mower engine lifted off of the deck so that the brake assembly can be removed.

7. Install the new BBC brake assembly directly to the engine crankshaft. In the case where the mower engine was lifted up, remount the engine to the mower deck.
8. Reinstall the BBC actuation cable.
