# BBC Clutch Installation

P-2110-WE  
819-0375

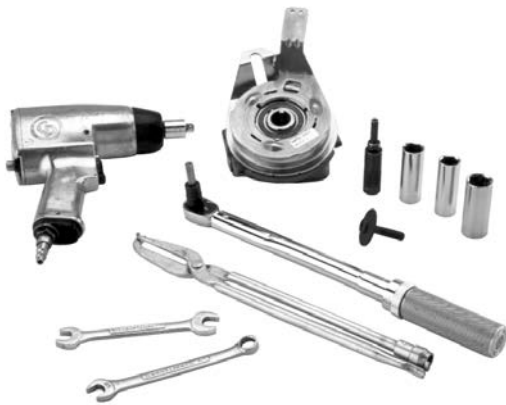
1. Remove the lawn mower blade from the BBC by removing the blade mounting bolts.
2. Remove the BBC mounting bolt.
3. Disconnect the customer supplied brake actuation spring.
4. Disconnect the BBC actuation cable.
5. Remove anti rotation bolt pin if necessary.
6. Remove the BBC assembly from the mower.

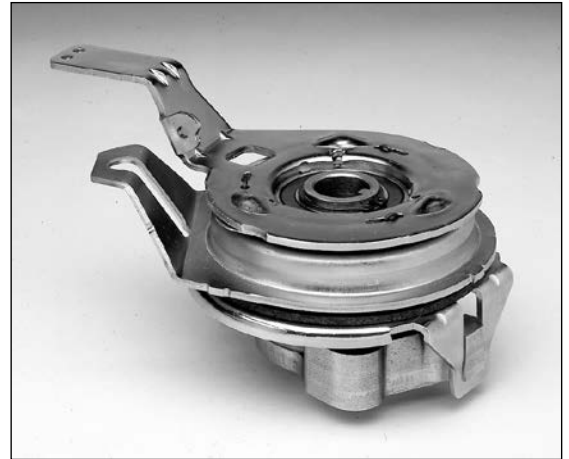
## Installation Instructions

**Note:** On some applications, the BBC brake assembly will not easily fit through the space allowed in the mower deck. In this instance, the mower engine mounting bolts must be removed and the mower engine lifted off of the deck so that the brake assembly can be removed.

7. Install the new BBC brake assembly directly to the engine crankshaft. In the case where the mower engine was lifted up, remount the engine to the mower deck.
8. Reinstall the BBC actuation cable.

**NOTE:** A minimum of 150 in.lbs. (16.95nm) of torque is required to move the actuation arm from the fully clutched to the fully braked position.

9. Reinstall the BBC mounting bolt. Torque the BBC mounting bolt to 48 ft-lbs. (65 N-m) for a 3/8-24 UNF or a M10 x 1.25-6g mounting bolt (contact Warner Electric personnel for assistance with other thread sizes)
