# Application Profile

## SS700 Reducers with High-Pressure Seal Option

## **Poultry Processing Lines**

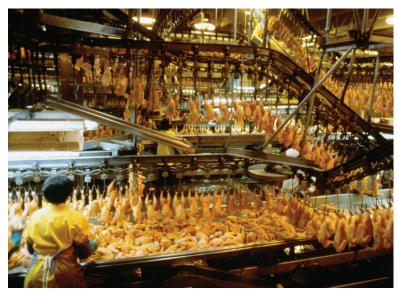
The new seal option incorporates an additional stainless exterior seal for rigidity, but also has a housing modification that maintains the seal joint as well as preserving the smooth exterior of the gearbox. This stainless cover rotates with the shaft while providing protection to the double-lipped seal in the unit. This added protection has withstood pressures up to 1000 PSI for over 200 hours without allowing water to damage the integrity of the oil. The new gearboxes have been installed and are successfully operating at their facilities. By being responsive to the voice of their customer, Boston Gear has been able to increase productivity by reducing downtime in an industry where production must keep pace with an 'insatiable' demand.
