# Flexi Clutch Rebuild

## **Offshore Oil Rig Fire Pump**

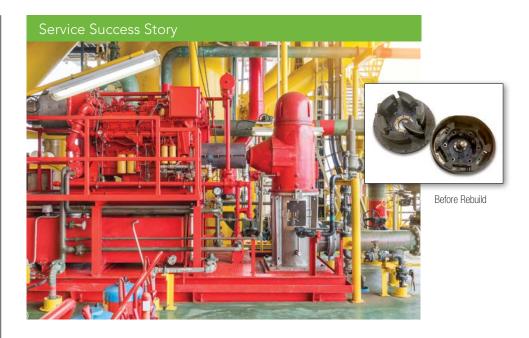
After Rebuild

- Fast 14-day turnaround
- Major components including drum, drum adapter plate, flywheel adapter plate, bearing housing, bearing stub shaft and hub were shot blasted and thoroughly cleaned
- Damaged friction shoes were replaced
- Fasteners, springs and bearings were replaced
- Returned to "like new" condition with a full 1-Year warranty

Upon arrival at the center, the clutch was stripped down and individual parts were inspected for suitability of re-use by Twiflex technicians and engineers. The main components such as the drum, drum adapter plate, flywheel adapter plate, bearing housing, bearing stub shaft and hub were all in good condition and able to be re-used. The fasteners, springs and bearings were all replaced as standard practice. Damaged friction shoes were also replaced.

The main clutch components were shot blasted, thoroughly cleaned, and re-painted. The clutch was re-assembled using new and existing parts. A new serial plate label was added for future ease in identification. The re-assembled clutch was set and tested to meet the customers specifications. The refurbished clutch was shipped back to the customer in "like new" condition with a full 1-year warranty.
